From The Workbench

Servicing the H.M.V. "Nippergram" – Series 31, 33, 35 and U63C

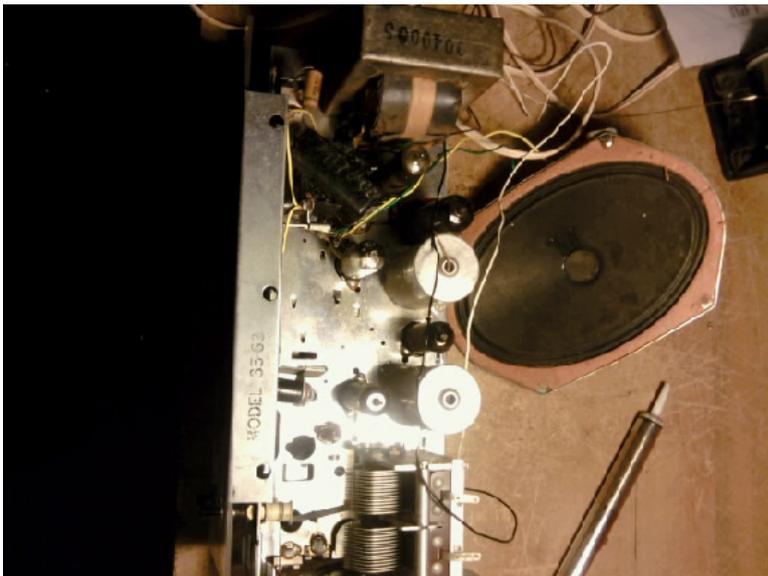
Step 3: On "switch on", the set was losing R.F. (Radio Frequency) signal. By disconnecting L1 from L3 and connecting the aerial to the top of L3. Also connect C4 to the bottom of L3 and disconnect the bottom of L3 totally from S2. Connect the top of L3 to V1. Remove S2 totally electrically from the R.F. circuit. Disconnect L6 from L5. Disconnect V1 cathode (V1k) from L6 and reconnect V1k to the tapping on L5. It is now a Broadcast receiver and not Shortwave.

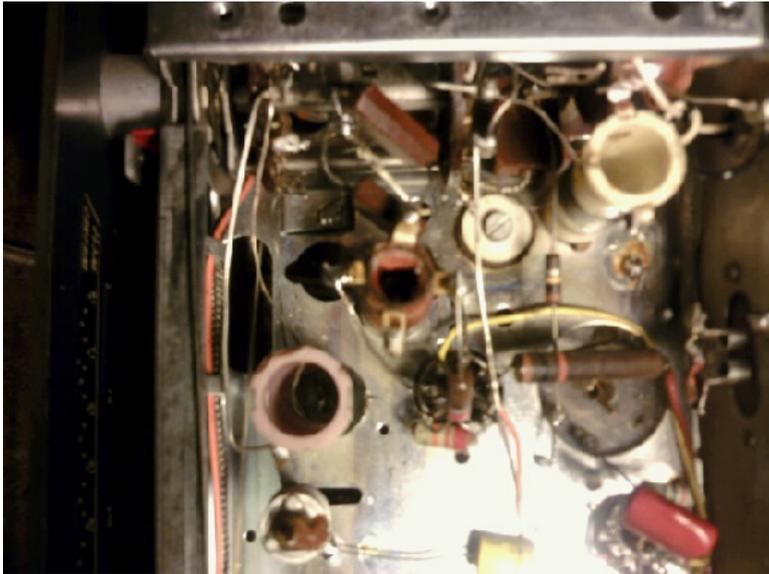
Step 4: Turn on the radio again. Much improved sound output now, but of course, no short-wave signal will be heard. The Paxelin switch wafers for some strange reason appear to be shorting out the RF signal. The AM band was loud and clear.
