# **S.A. GROUP NEWSLETTER**

**April 2015 Special**

## Historical Radio Society of Australia Inc. – S.A. Group

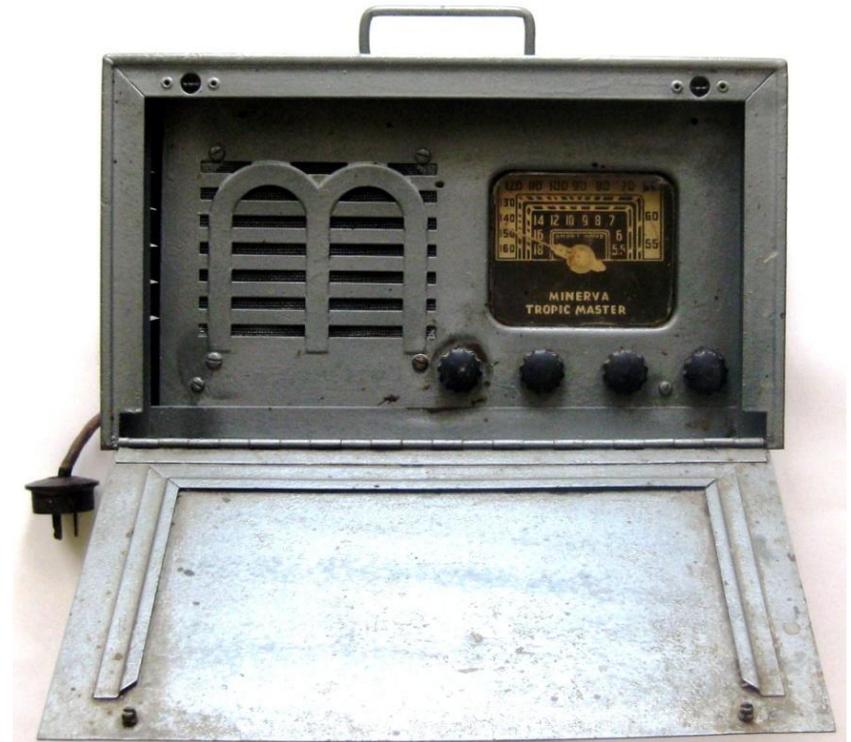
**Minerva Tropic Master**

The Minerva Tropic Master which will be for sale at the forthcoming auction.

**Minerva** *Tropic Master* dual band receiver in a metal box with a front cover. This type of receiver was produced to sell to U.S. military personnel serving in the South Pacific area during World War II, however the War ended abruptly before sales were firmly established. The receiver is reputed to have been supplied to refugee camps in Europe after World War II. ***AC/DC live chassis should be used with an isolation transformer, the case is isolated from the chassis***, 550 – 1600 kHz, 5.5 – 19 MHz. 1945-1947

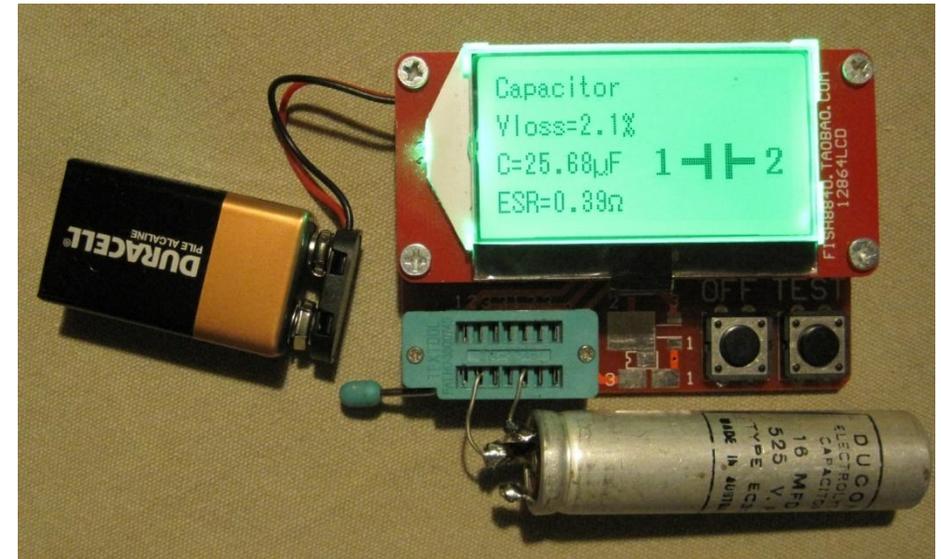
### All-in-1 Component Tester Transistor Diode Capacitance ESR Meter Inductance

I wanted an ESR tester, and with a quick web search I found the meter above for about \$US20, post free from China. It turns out to measure many things: see the specification below. As you can see in the photo, ESR works well. I am wondering if I really needed to replace the above capacitor in that old Astor radiogram.

Do a web search on the title above, and you will find a whole lot of variations on offer. This is where it gets complicated. My unit, which was made in July 2014, uses an old circuit that in off mode consumes 0.2 mA. There is a web page that describes a very simple modification to switch a 47 k resistor across the battery to a position after the electronic power switch. Later models have included this change, and now specify a shutdown current of 40  $\mu$ A. I can either wire in an on/off switch or modify it. Probably I will be too busy, and just disconnect the battery.
