# From The Workbench

By Chris Ratcliff

This is a Philips Model 167, which was brought to me by a collector, who had replaced the capacitors including the two electrolytics, but when it was powered up, R12 became so hot that it smoked!

This repair became “Perry Mason and the Case of the Smoking R12”.

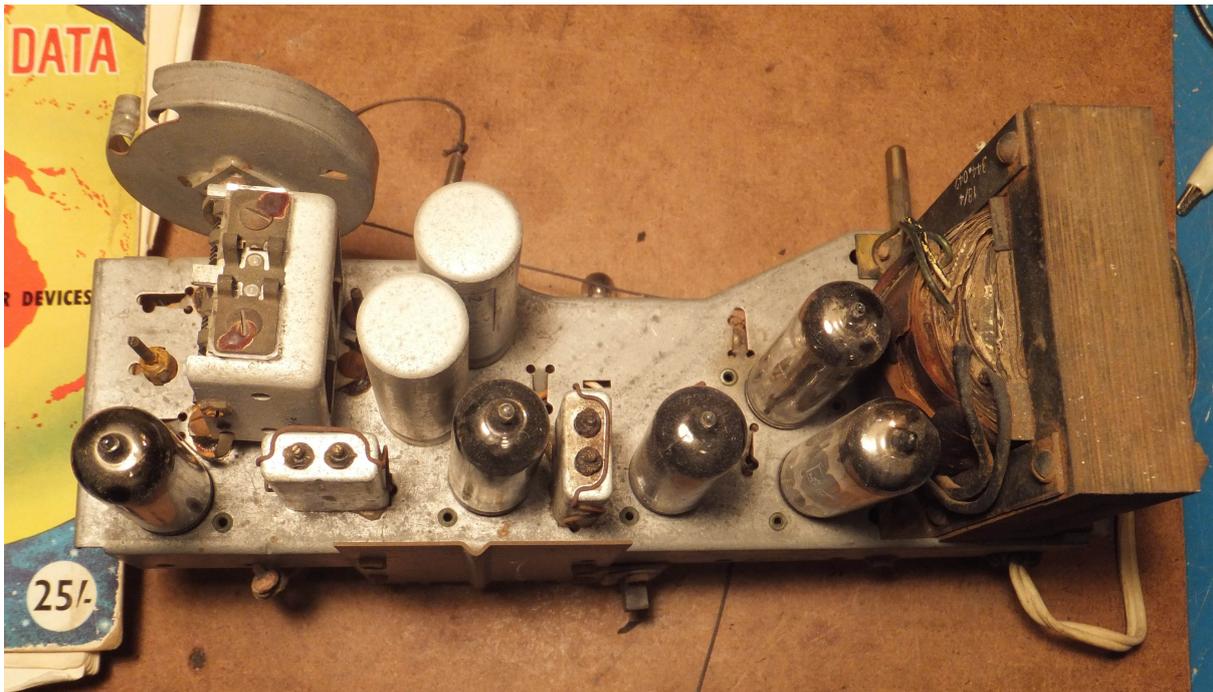
From the circuit diagram below, you will see that R12 is a 1K x 1W resistor and is used as a filter device, in place of a filter choke. Using my Ohm-Meter between the chassis and the C18 side of R12 there appeared to be a dead-short. The two original electrolytic capacitors, C17 and C18 were chassis mounted and their tags were used as wiring and component terminations. Although disconnected, the replacements terminated above the old capacitors. The replacements had to be moved elsewhere on the chassis to gain access to the wires that terminated at C18. Dividing these 3 wires, and individually placing my Ohm-meter on each wire, would tell me where in the radio the short was located.

Using this method, the dead-short was easily located as being in the Intermediate frequency (IF) stage of the radio. So then I figured that I needed to check the valves. I pulled out the EBF80 (6N6) valve. It was NOT an EBF80 but ECH80(6AN7) which I was expecting to be in a different socket. On closer inspection it was obvious that these two valves had accidentally been swapped in position when the person had replaced the capacitors!

EBF80's Anode is pin 6. ECH80's pin 6 is an internal connection which shorted out the H.T. via L7 which is connected to the primary winding of the I.F. transformer - It was VERY lucky that no further damage had been caused!!

I returned the EBF80 to its original position and installed a replacement ECH80 and a new 1K x 1W resistor. Finally, I powered up the radio and it worked!
